Technical Note 5-70

NOISE REDUCTION OF THE XM759 CARGO CARRIER (MARGINAL TERRAIN VEHICLE)

Howard H. Holland, Jr.

July 1970

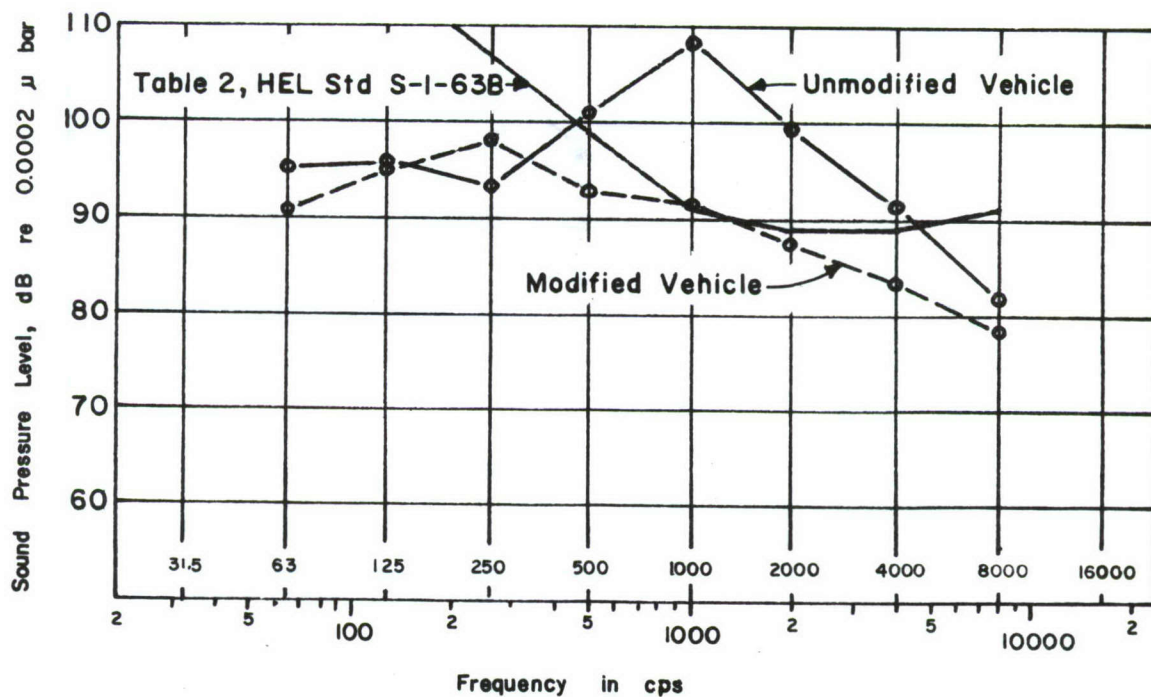
Fig. 29. OPEN CAB NOISE IN PILOT VEHICLE NO. 2 AT 4000 ENGINE RPM

All of the noise level results presented in this report are data obtained in the drivers' cab with the vehicles stationary and with the engines and cooling fans operating (except for the few cases when the fans were disconnected). The presentation of data involves Pilot Vehicles No. 2, No. 3 and No. 6. Data for Pilot Vehicles No. 3 and No. 6 have been presented on the same figures, while data for Pilot Vehicle No. 2 have been presented on separate figures. The reason for this method of presentation was the difference in location of the engine cooling system. Pilot Vehicles No. 3 and 6 had a system drawing air into the radiator directly behind the cab and exhausting the air out on the right side of the vehicles (Fig. 12). Pilot Vehicle No. 2 had a system drawing air in on one side of the vehicle and exhausting it on the opposite side (Fig. 8). The SPL results by octave bands are shown in Figures 14-31.

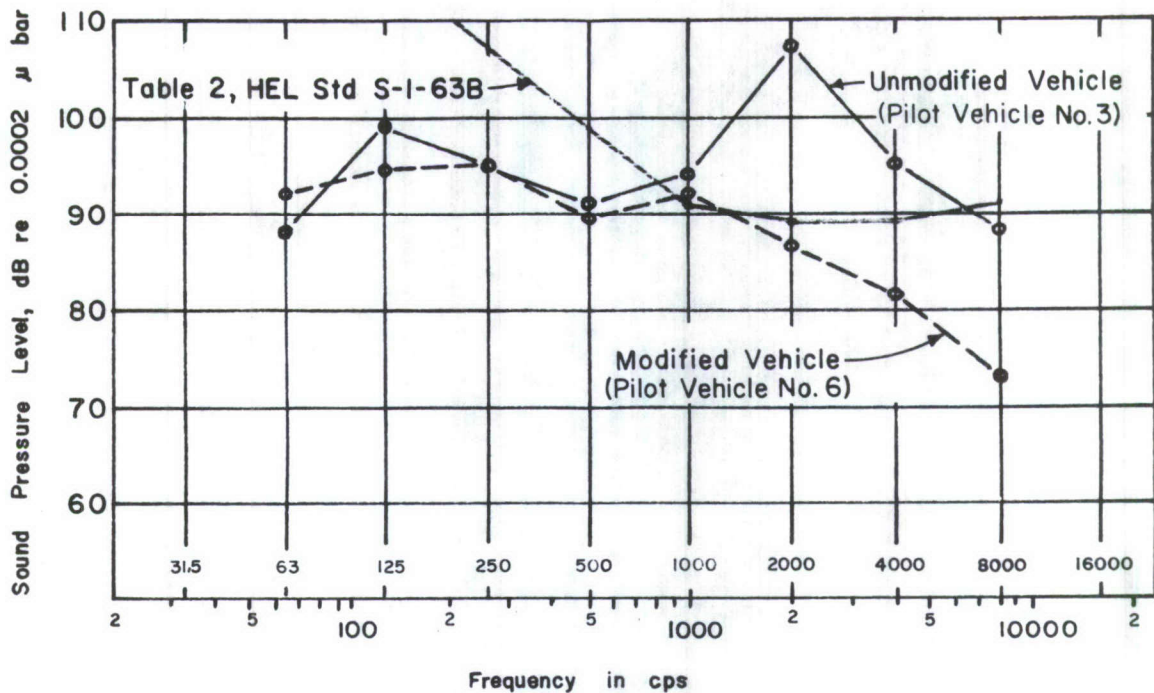
Fig. 30. AN OCTAVE BAND ANALYSIS OF THE CAB NOISE AT 4500 ENGINE RPM BEFORE AND AFTER MODIFICATIONS FOR NOISE REDUCTION (Note the large change in the 2000 cps band caused by reducing the pure tone noise of the fan. Vehicle No. 6 data is for a closed cab and Vehicle No. 3 is for a cab with the driver's curtain off.)

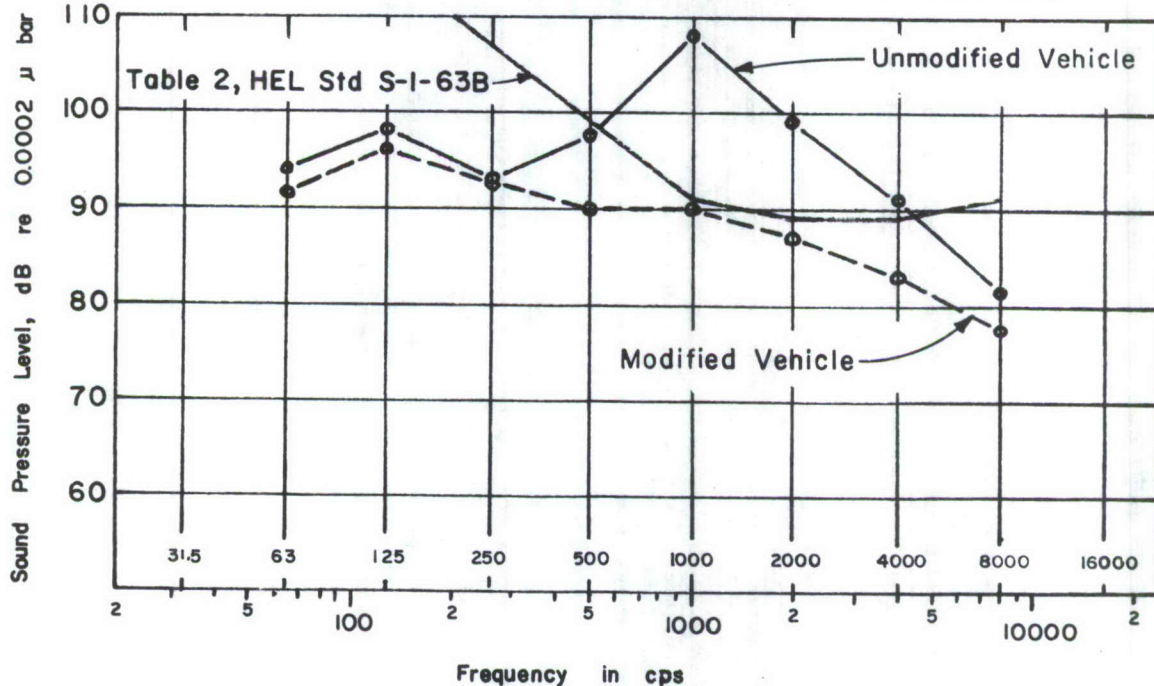
Fig. 31. AN OCTAVE BAND ANALYSIS OF OPEN CAB NOISE AT 3000 ENGINE RPM IN PILOT VEHICLE NO. 2 BEFORE AND AFTER MODIFICATIONS FOR NOISE REDUCTION (Note the large change in the 1000 cps band caused by reducing the pure tone noise of the fan.)
